Contract #: 04-0120F4Cty: SF/ALA Rte: 80 PM: 13.2/13.9File #: 1x.28**WELDING INSPECTION REPORT****Resident Engineer:** Casey, William**Address:** 333 Burma Road**City:** Oakland, CA 94607**Report No:** WIR-027419**Date Inspected:** 09-Apr-2012**Project Name:** SAS Superstructure**OSM Arrival Time:** 700**Prime Contractor:** American Bridge/Fluor Enterprises, a JV**OSM Departure Time:** 1530**Contractor:** American Bridge/Fluor Enterprises, a JV**Location:** On Site**CWI Name:** Bernie Docena**CWI Present:** Yes No**Inspected CWI report:** Yes No N/A**Rod Oven in Use:** Yes No N/A**Electrode to specification:** Yes No N/A**Weld Procedures Followed:** Yes No N/A**Qualified Welders:** Yes No N/A**Verified Joint Fit-up:** Yes No N/A**Approved Drawings:** Yes No N/A**Approved WPS:** Yes No N/A**Delayed / Cancelled:** Yes No N/A**Bridge No:** 34-0006**Component:** Bike Path Skyway Portion**Summary of Items Observed:**

Skyway Portion of the SFOBB:

CCO: 193 - Description: Modify the existing bikepath panels at the expansion joints of the Skyway portion of the SFOBB East Span Seismic Safety Program.

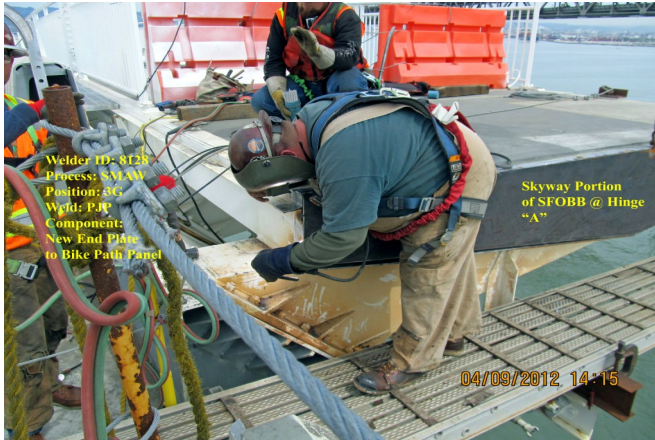
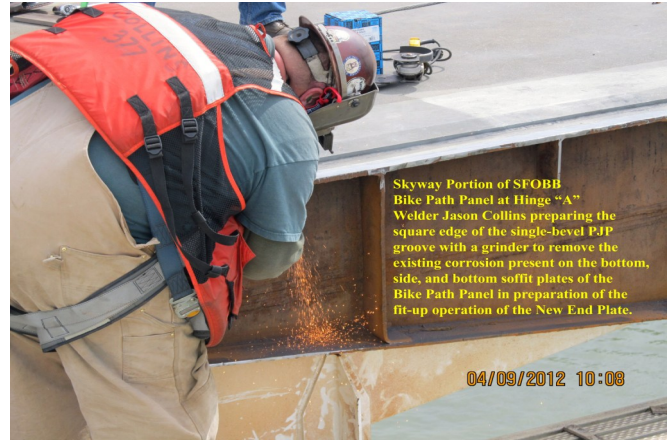
This QA Inspector randomly observed ABF welder Mr. Jason Collins (Welder ID 8128) performing the tack-weld operation on a partial-joint-penetration (PJP) groove weld per the Shielded Metal Arc Welding (SMAW) process in the (1G) flat position connecting the new end plate to the existing top plate of the bike path panel at the expansion joint Hinge "A" as per ABF Submittal no. 2549R1 of Contract Change Order (CCO) 193.

At the Expansion Joint Hinge "A", this QA Inspector previously observed ABF personnel cut back the top and side skin plate and diaphragm plate using an oxyacetylene cutting torch on a track system and also observed the ABF personnel use a mechanical cutting blade on the existing soffit plate of the bike path panel. The cut back distance was measured at 116 mm as per Contract plan sheet number 1164S7 and ABF Submittal number 2549R1.
